Stormwater & GI – Wed. 11.4.15 CB8/BCEQ

Water Working Group of the
Environment and Sanitation Committee of Bronx Community Board 8 & the
Bronx Council for Environmental Quality

TOUR WITH THE NYC DEP GREEN INFRASTRUCTURE TEAM

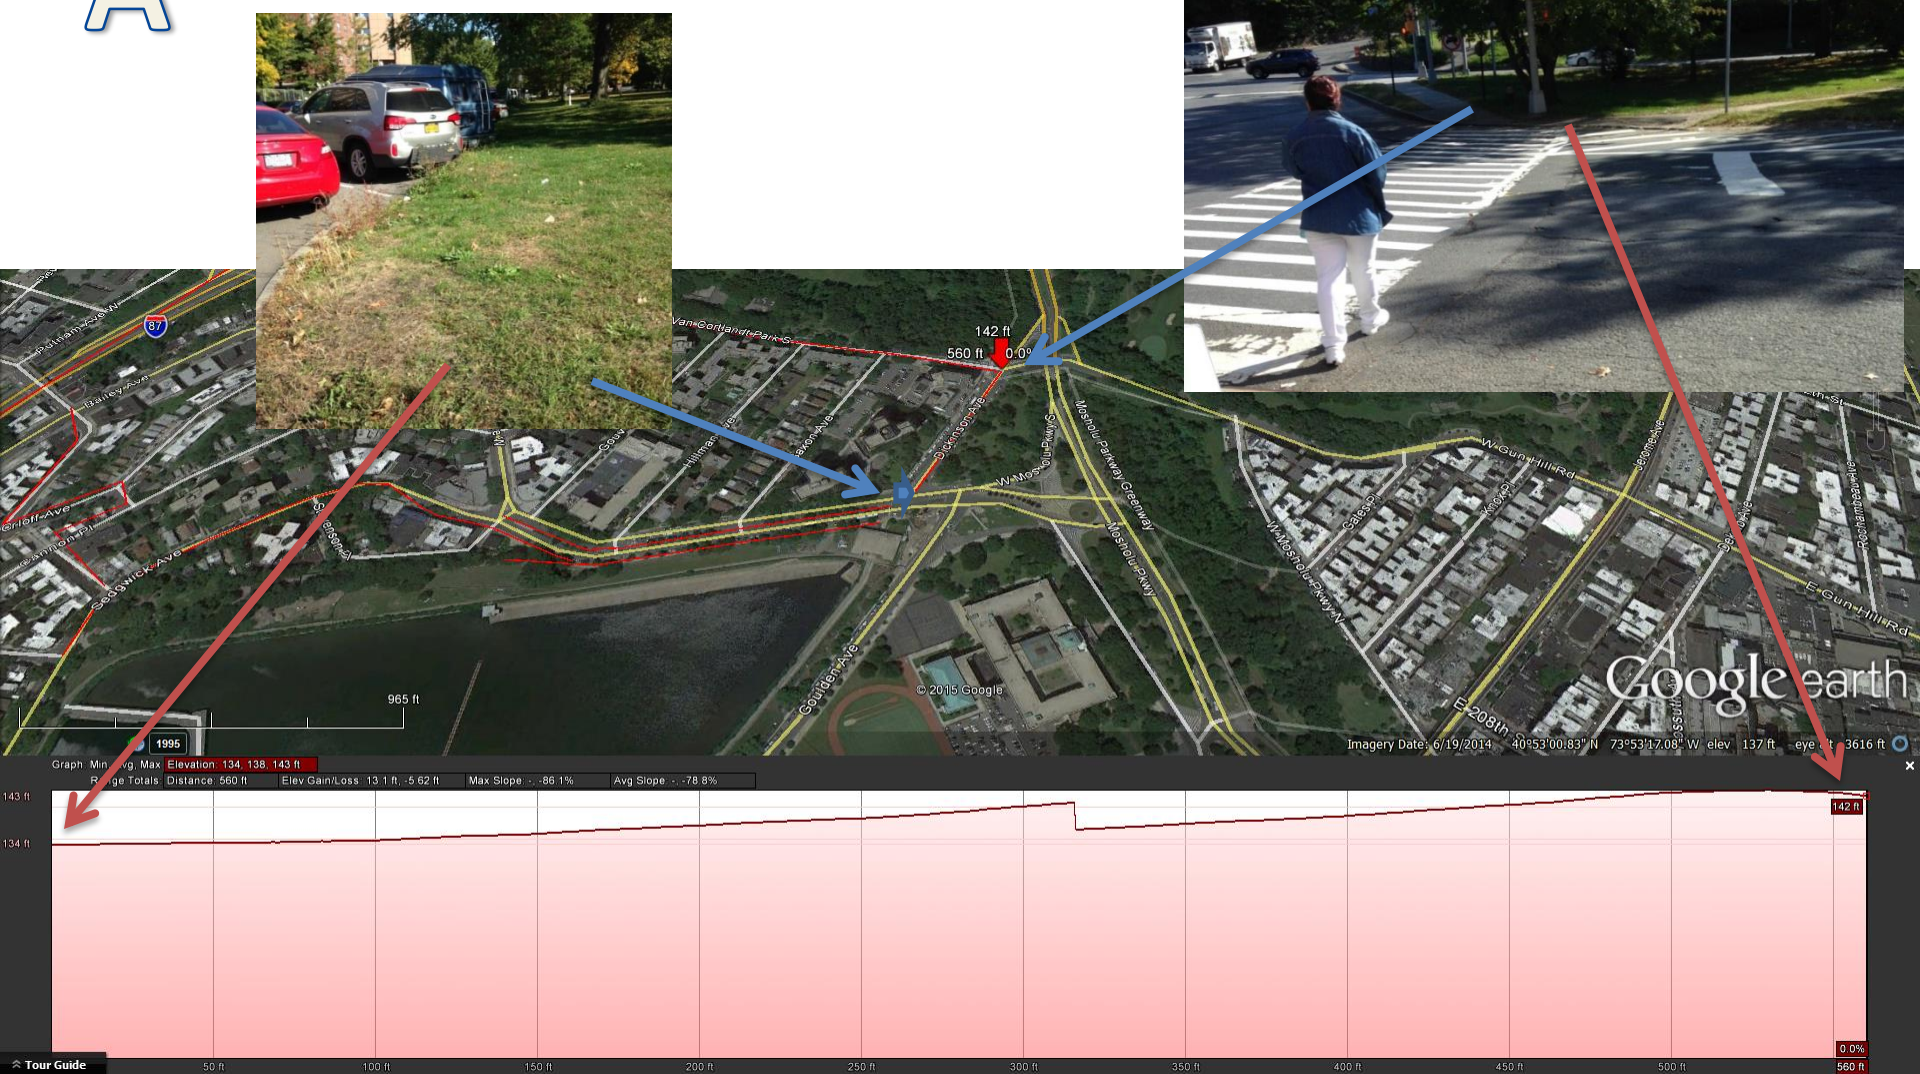
Van Cortlandt Park South starting from Dickenson (142 ft) to Gale (82 ft) & then to Bailey (20 ft) where it floods around 225th Street

Stormwater is so fast and fierce that it goes down hill and makes a left turn at Gale Place. Along VCPS there is room for Enhanced Tree Pits on both sides of the street. DEP could partner with Amalgamated to capture additional rainfall by adapting from using grass to other plantings, green roofs, rain barrels, etc. Consider this opportunity to partner with a great housing cooperative.

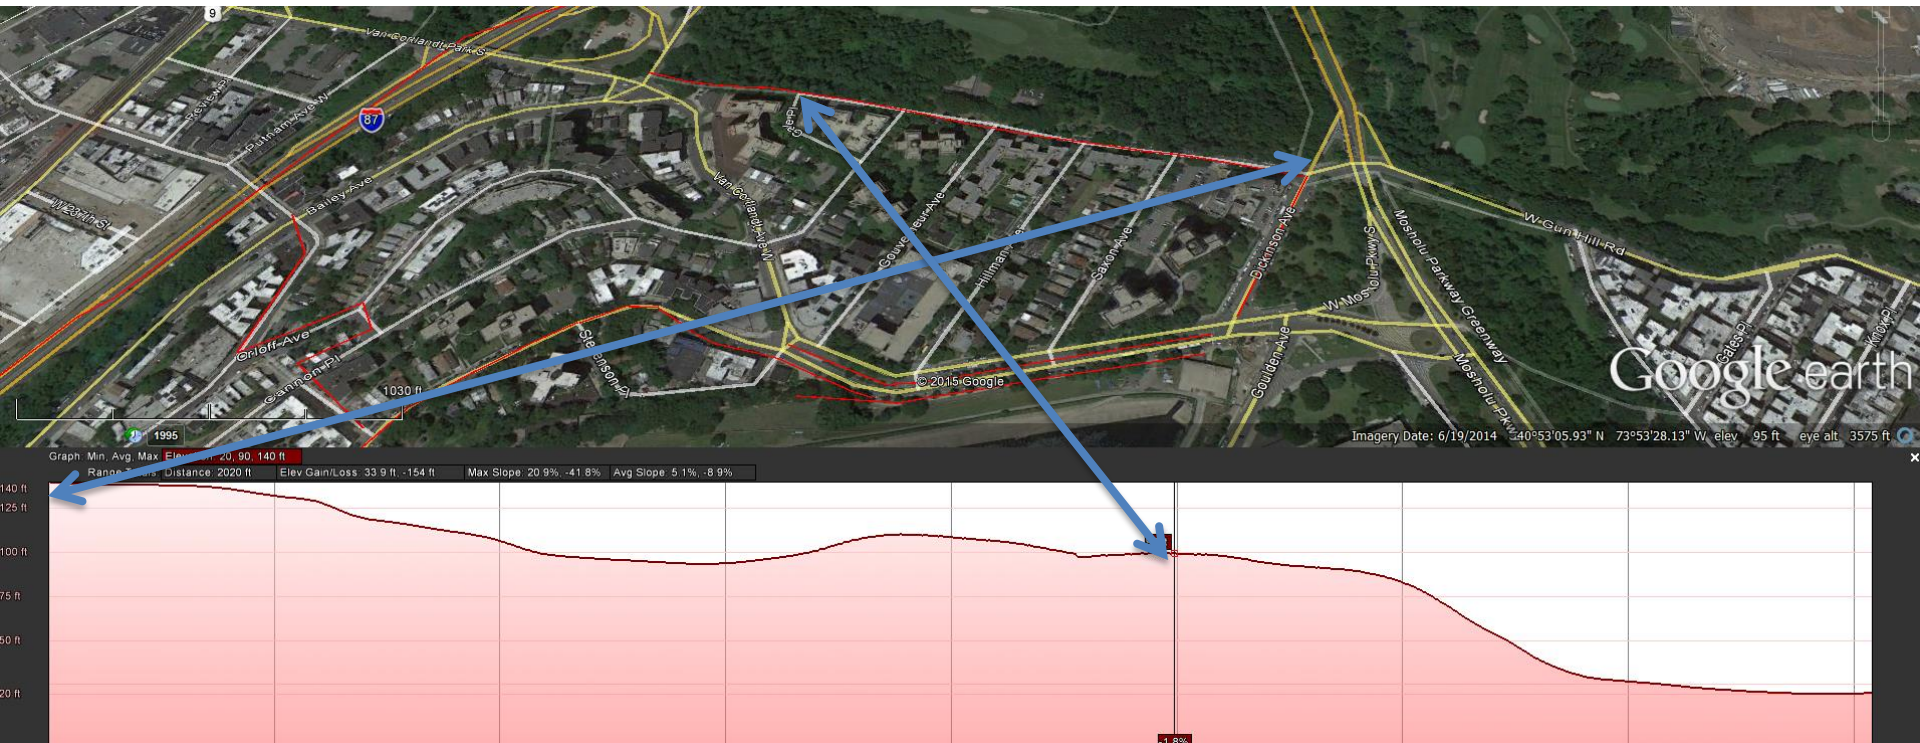
This is by St. Patrick's Home. It is another opportunity to do something creative on the street, with local institutions adopting the care.

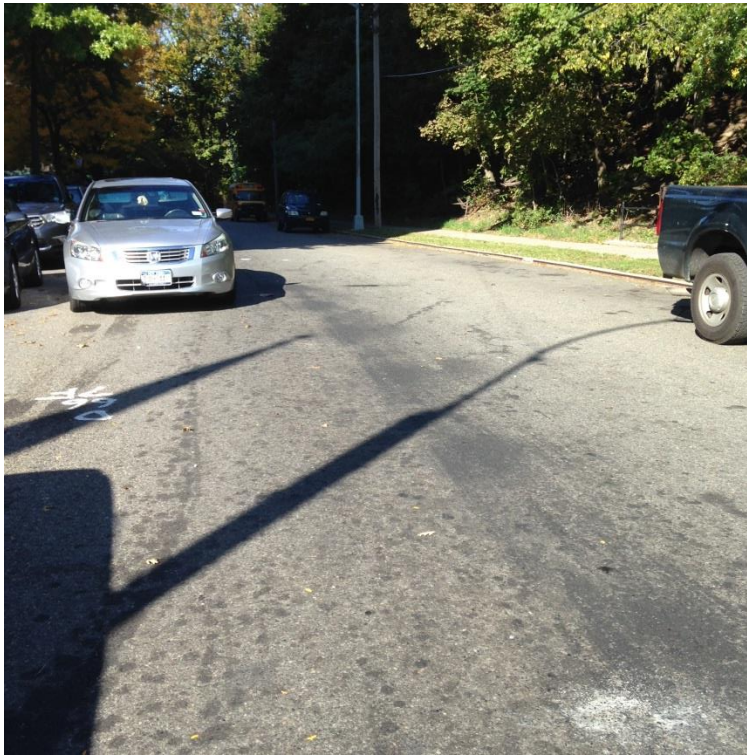
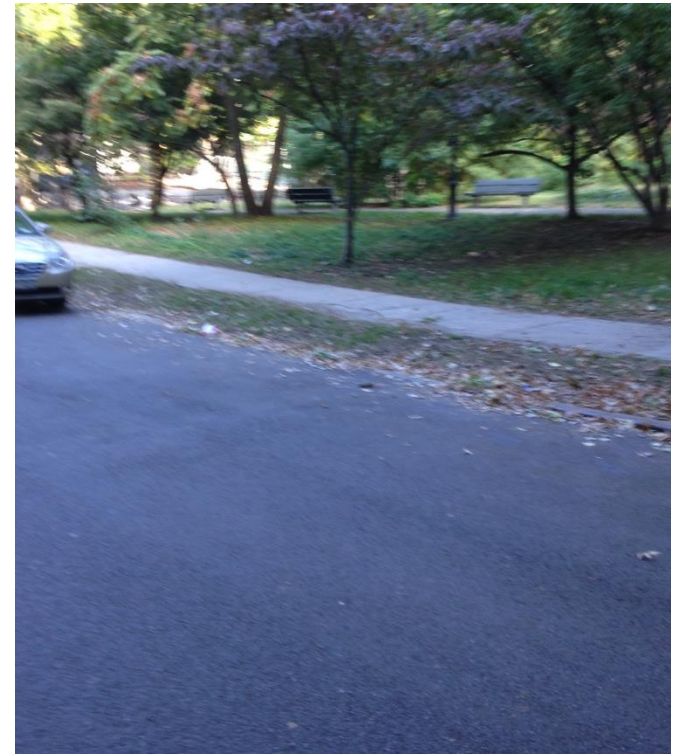
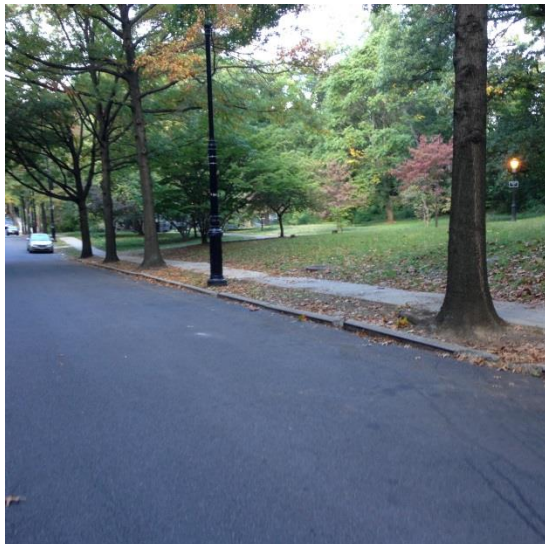
This is VCP. Its plain to see the park side has its stressors which could be fixed with some bioswales, enhancing the tree pits, and other available options.

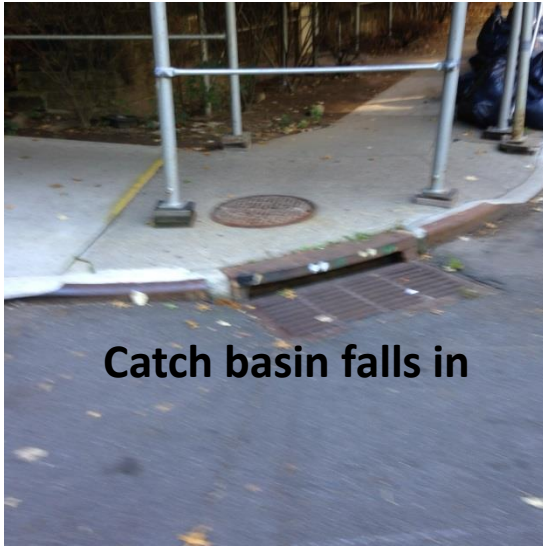
Catch basin falls in

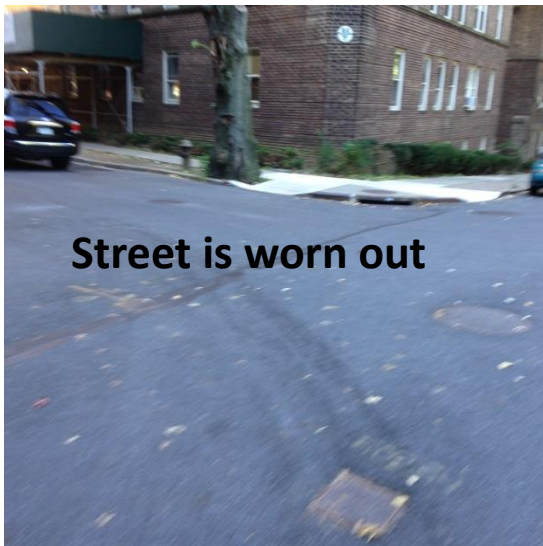
Street is worn out

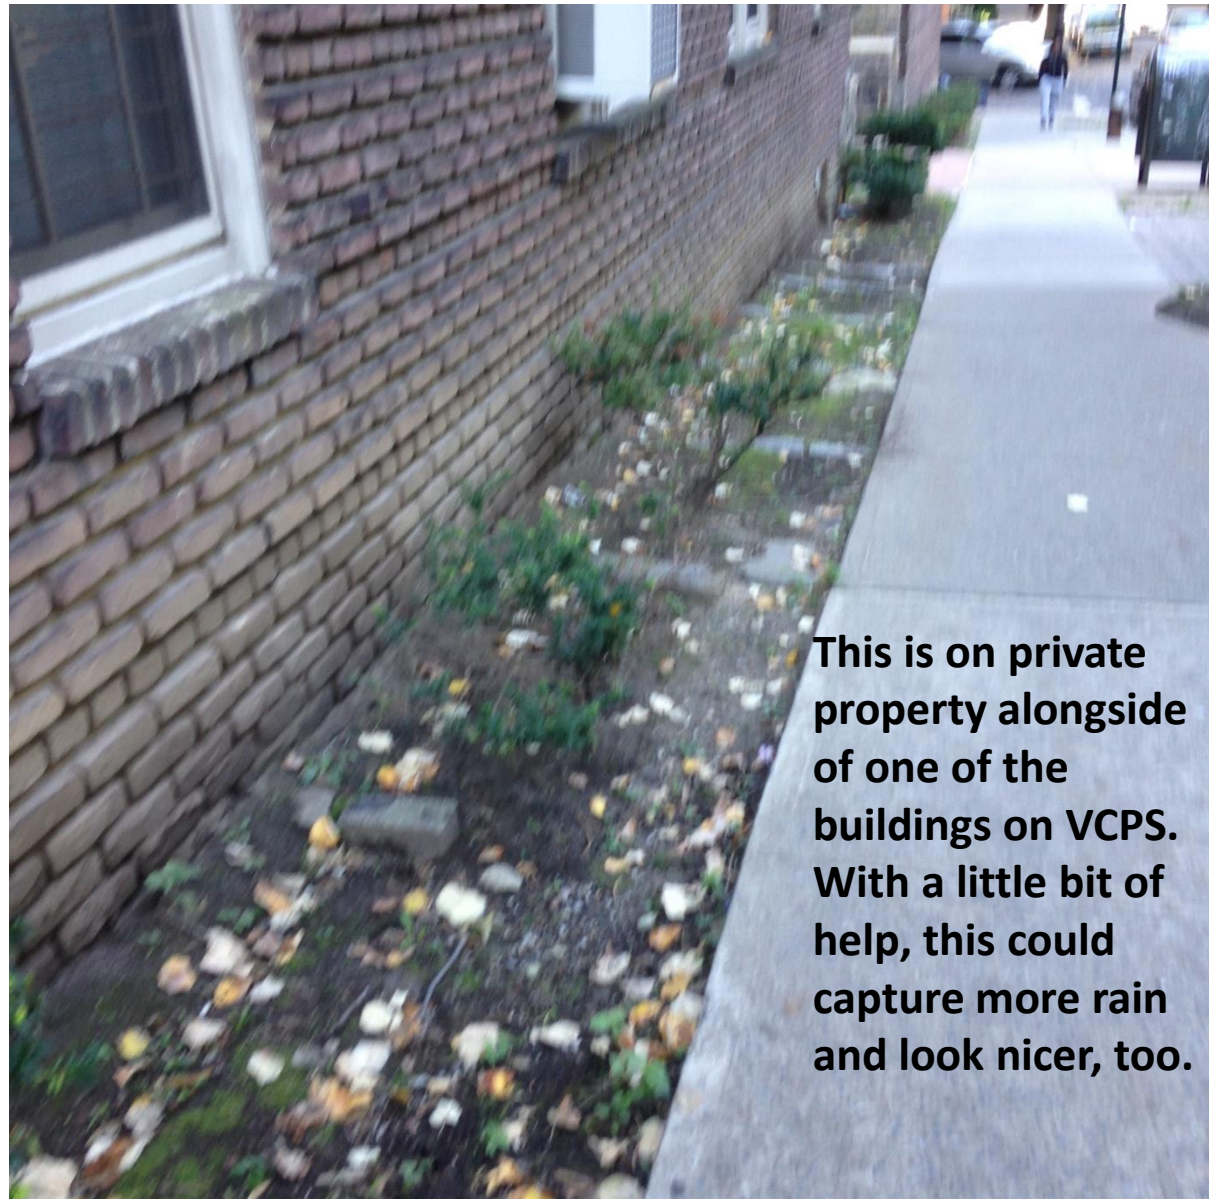
This is on private property alongside of one of the buildings on VCPS. With a little bit of help, this could capture more rain and look nicer, too.

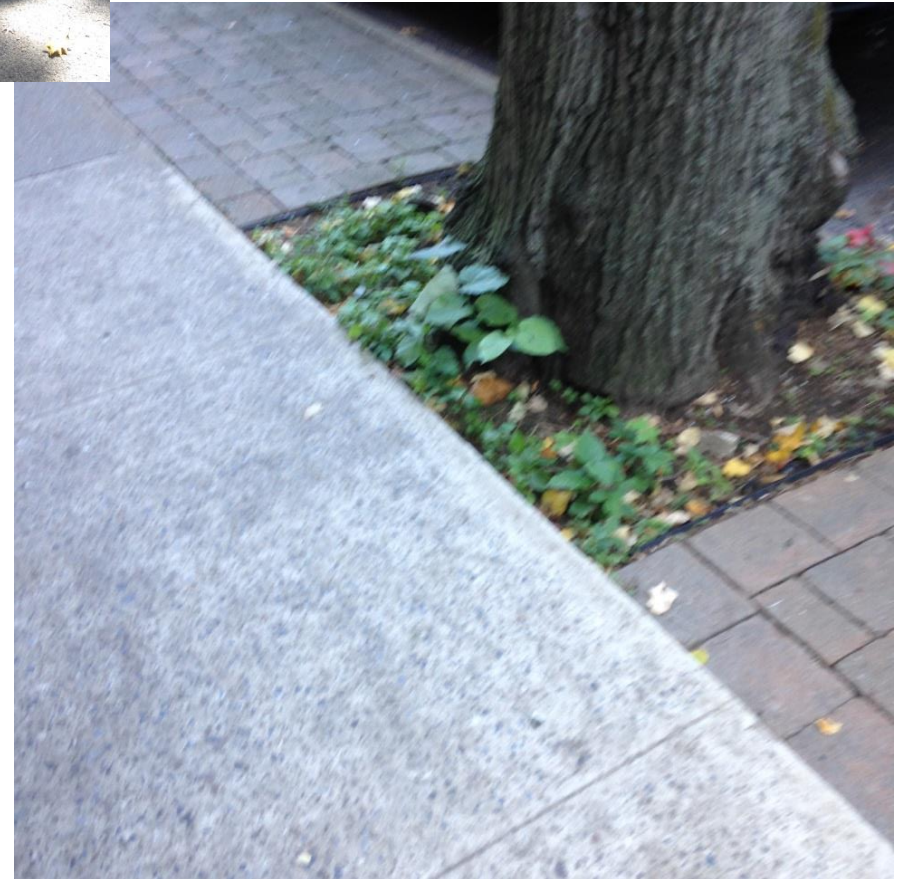
This is on the edge of the children's park in VCP. The runoff is evident even in this year of low rainfall.

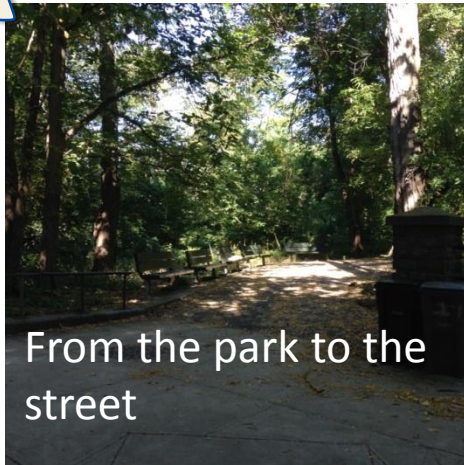
From the park to the street

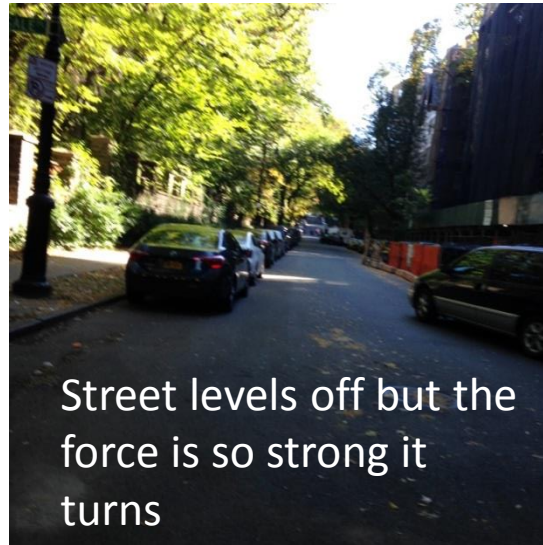
Street levels off but the force is so strong it turns

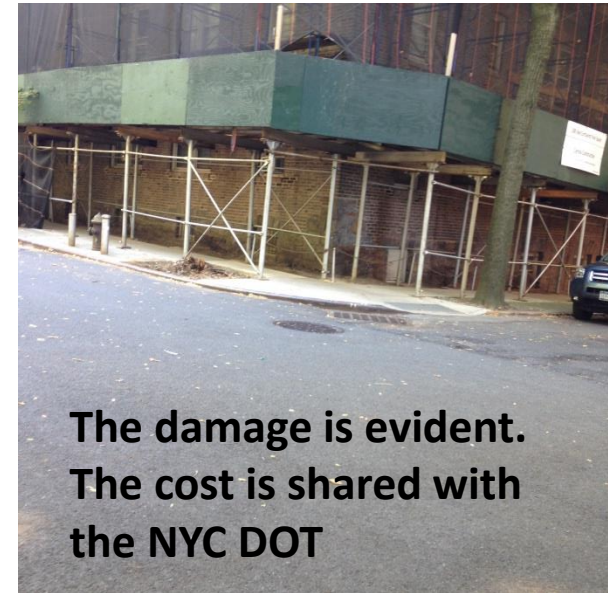
The damage is evident.
The cost is shared with the NYC DOT

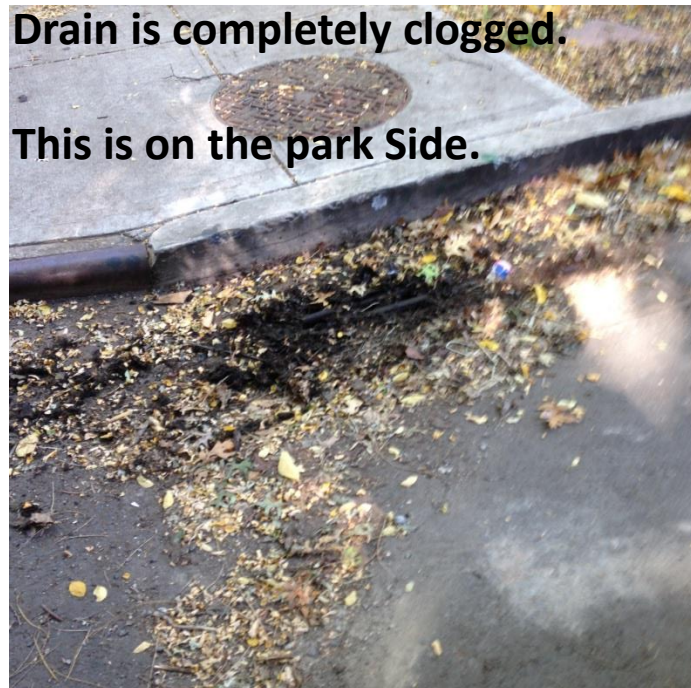
Drain is completely clogged.
This is on the park Side.

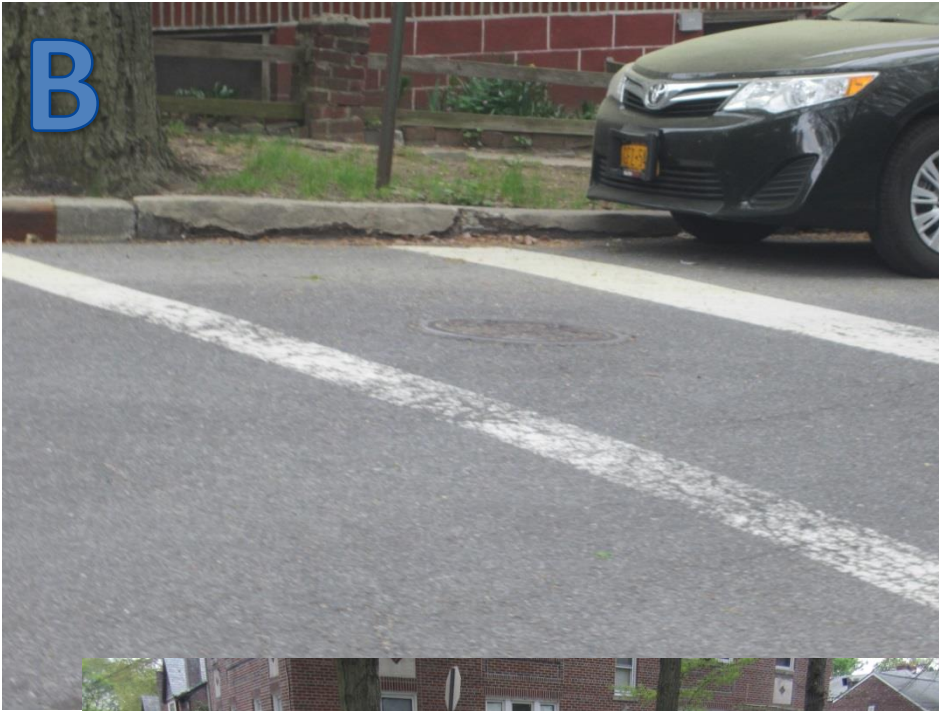
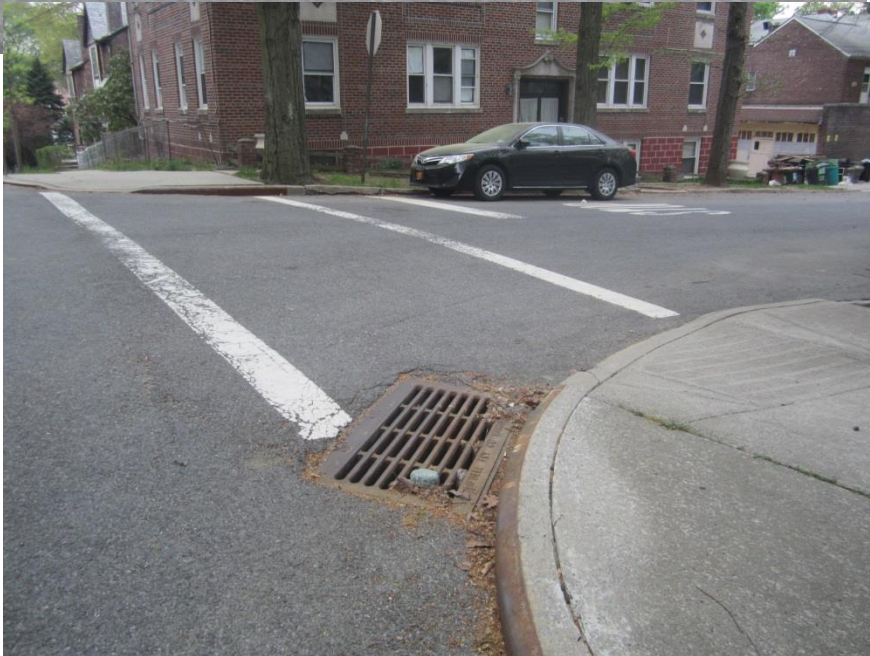
Stormwater runs down W. 260th Street

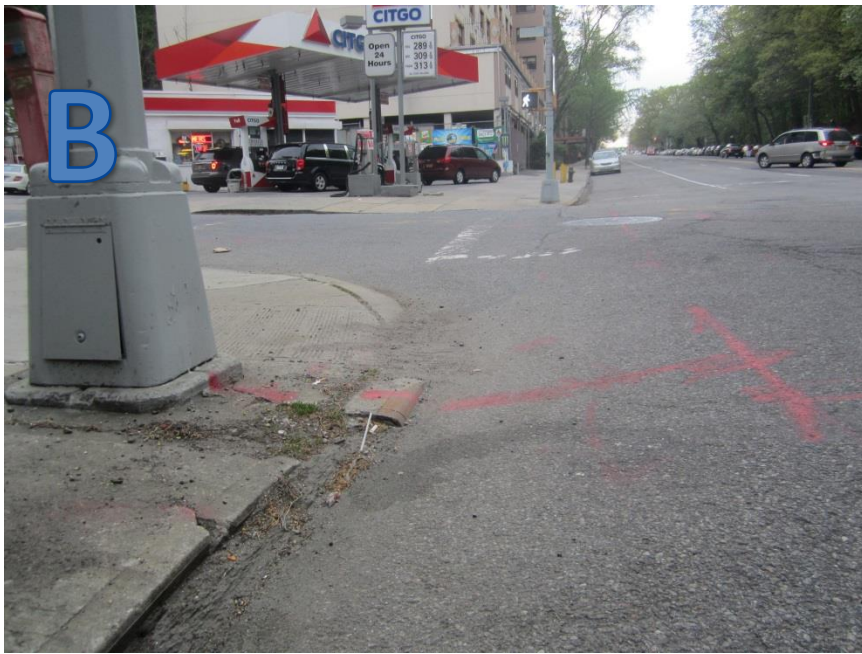
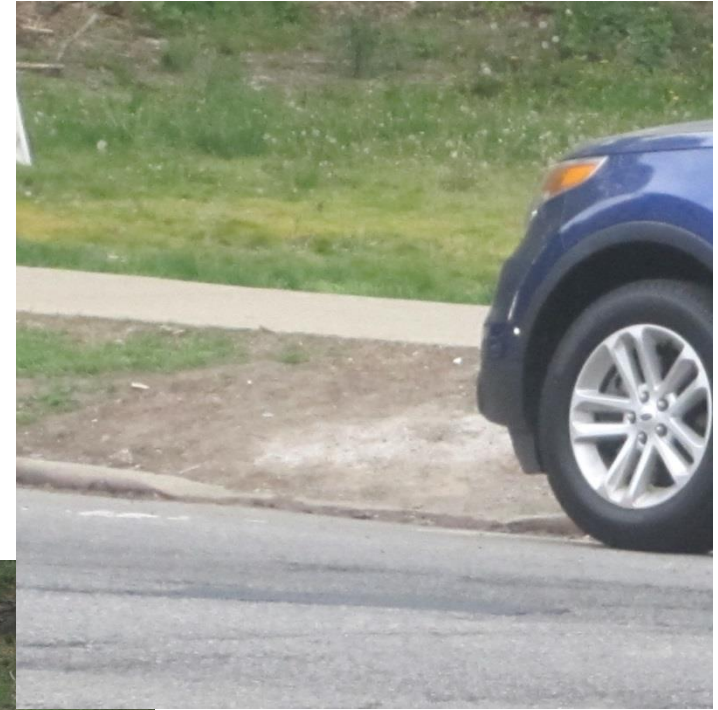
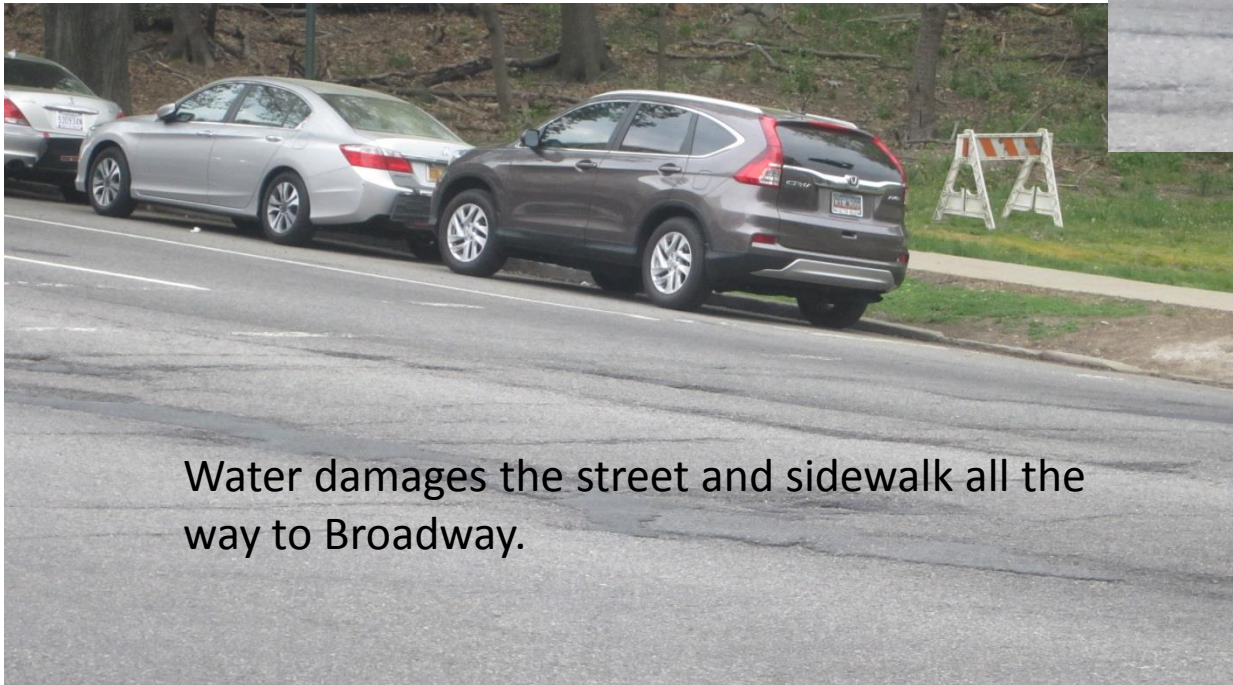
Water damages the street and sidewalk all the way to Broadway.

Broadway at 230th Street has water damage even though the roadbed is raised in the middle.

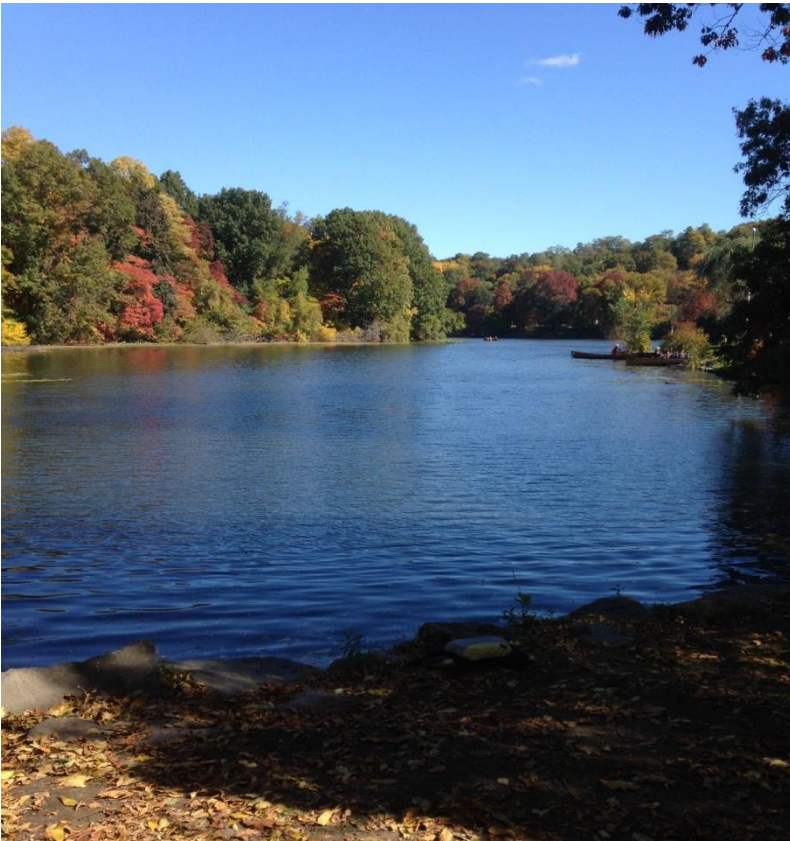
Existing condition has stormwater discharging into Van Cortlandt Park waterbodies: Tibbetts Brook, the Wetlands or the lake – the 56 acre NYS Class I Freshwater Wetland, known as Van Cortlandt Park Wetland.

The NEW design for the trail can no longer discharge into the water body. SWPPP must be for design, as well as but not just construction and E&S.

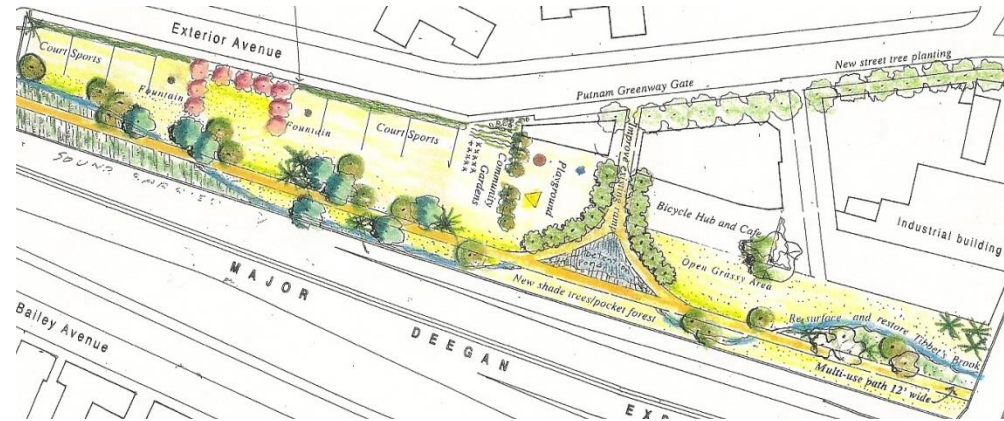
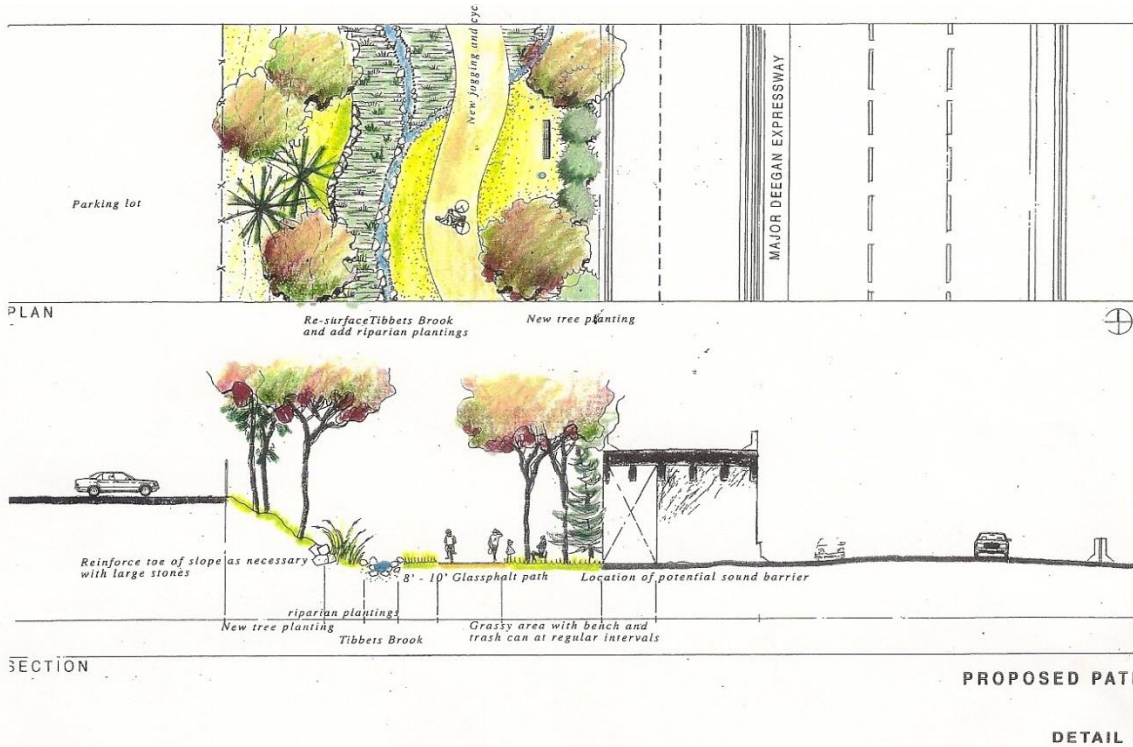
South of VCP in the rear yard of Broadway stores and along the Major Deegan

This area is lower than the Broadway stores. It is hard to reach, but it is easy to assume that it floods. During Sandy the Harlem River surged to 238th Street.
