Jerome Park Reservoir & Aqueduct Rehabilitation

Sedgwick Avenue, Goulden Avenue & Reservoir Avenue, Bronx

May 2019

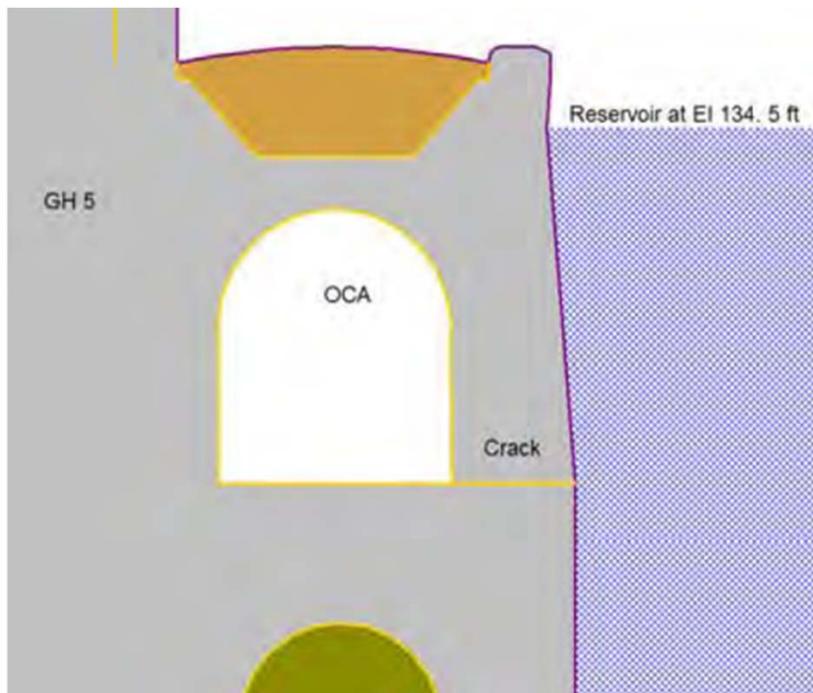
Diagram illustrating crack causing leakage into the reservoir basin

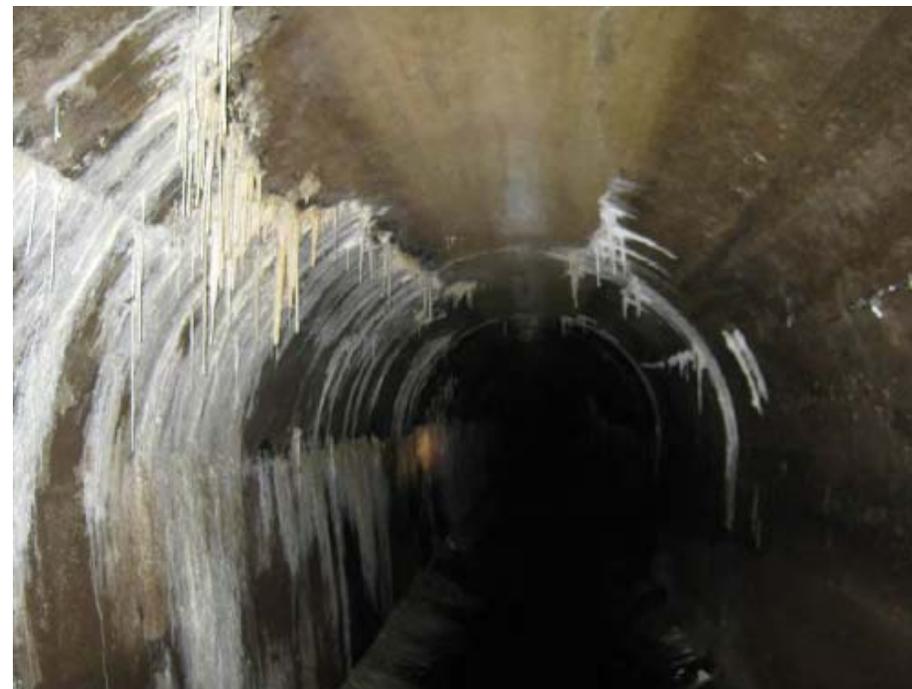
Photo of Old Croton Aqueduct interior

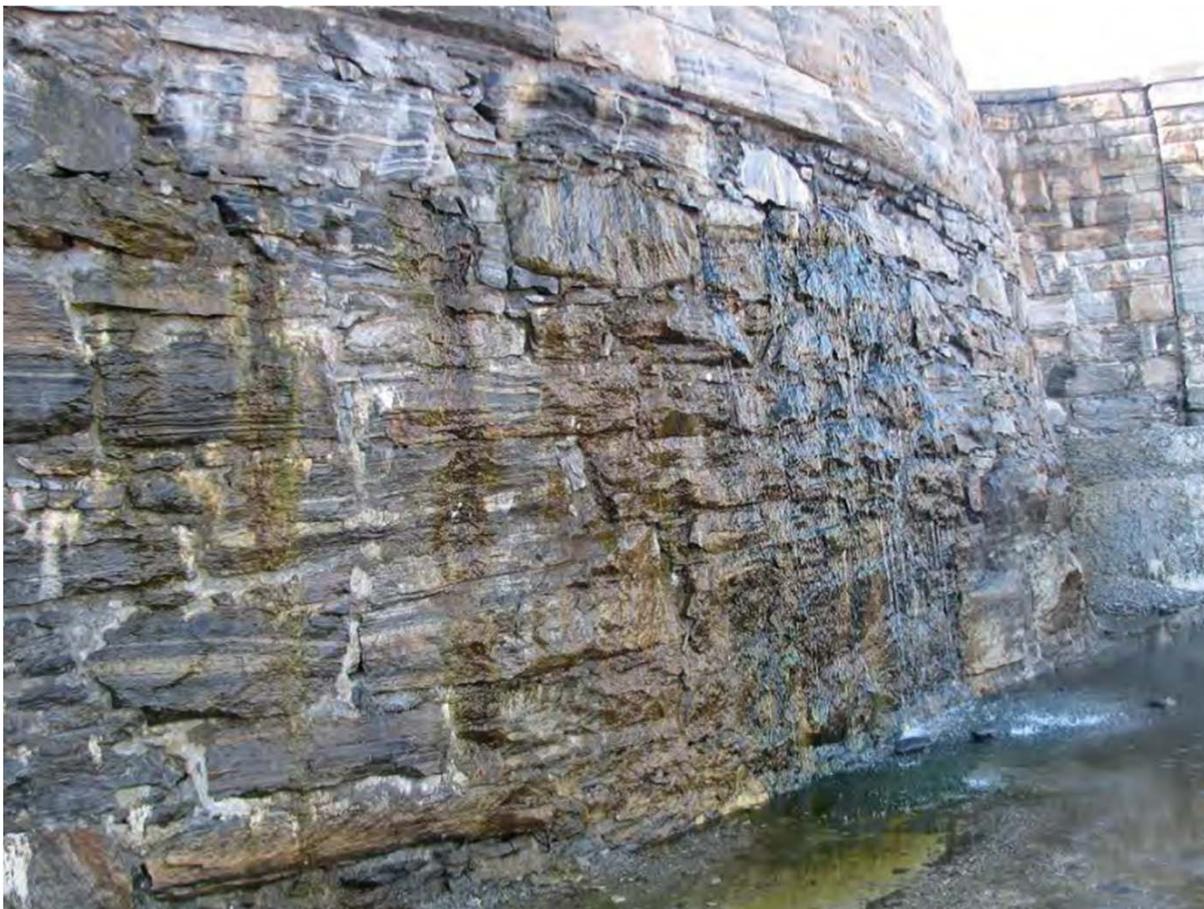
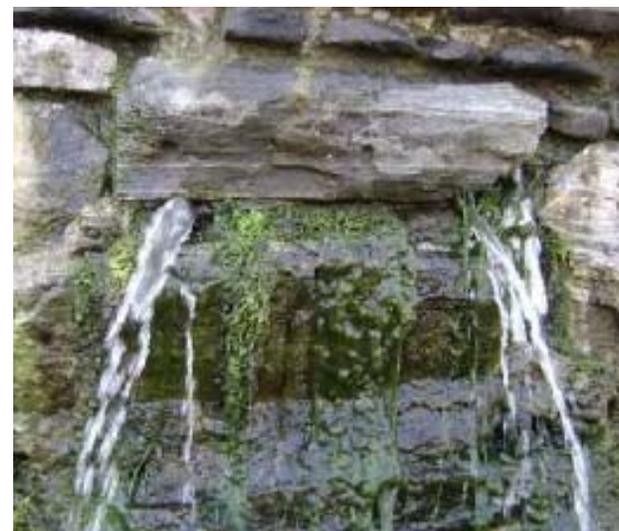
Leakage into the reservoir basin and severe deterioration of the east wall
